BD Loops

Phasing Test

Observations of the effect phasing has on loop detection when two loops are hooked in series on each side of a slide gate or overhead door

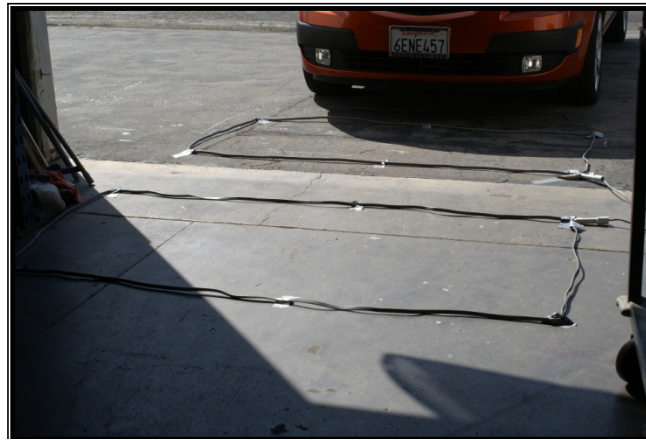
Figure 1

Picture of how the loop were positioned

Testing area was prepared by sweeping the surface so the duct tape will easily stick to hold loops in place. Loops were positioned in 3x9 dimensions, 2ft away on each side of the overhead door. Duct tape was used to hold loops into position. The lead-in of each loop was then hooked in series, out of phase to the EDI detector. After making sure the overhead door was in its complete open position, the detector was set to a sensitivity level of 5 and

While the loops were still properly phased they were pushed inward towards the overhead door to see how close two loops could be before a detector occurs. Each time the loops were positioned 1 inch closer on each side at the maximum sensitivity setting (9), resetting the detector, opening and closing overhead door until a detection was recorded. The distance on each side of the door was then recorded.
