BD Loops

1/8" Groove Test

Observations of 1/8" saw-cut grooves and how well they are sealed in asphalt or concrete

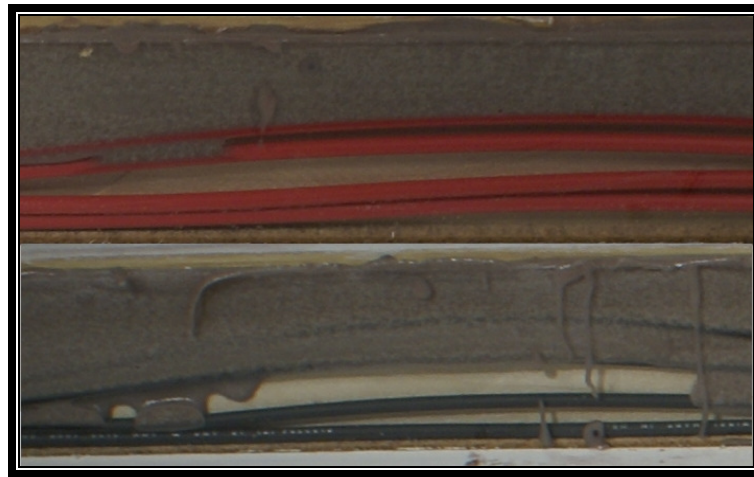
Figure 2

Picture of air-pocket after sealant has been applied

Results show regardless of the viscosity and type of sealant used that a 1/8" saw-cut groove will not fully seal the wires, allowing space for an air-pocket (see *Figure 2*).

If a 1/8" saw-cut blade is used then the groove will not be completely sealed and air-pockets will be present which cause several intermittent loop problems.

Air pockets within the groove can cause a number of problems resulting in repeat service calls. Air pockets within the loop design allow space for the wires inside to move, when the wires move even slightly a false detection will occur. In colder temperatures air-pockets can cause even more problems by pushing the entire loop out of the saw-cut groove. This occurs when water enters the air-pocket and freezes. When water freezes it expands, that force will push the loop out of the groove completely. This then makes the loop susceptible to traffic and nature's wrath eventually causing the loop to short to ground (fail).

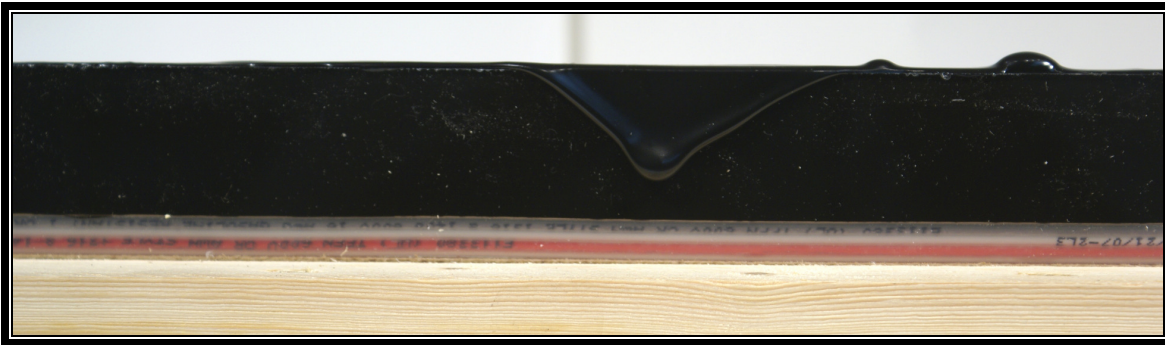
Figure 3

Picture of a BD Loops saw-cut in 1/8" Plexiglas with no air-pocket

Results show that installation of BD Loop's preformed loop will not allow air-pockets to form. (see *figure 3*)
